Manhole Inspection Summary

Manhole # S53E__017MH

Insp Date: **4/28/08 8:55 AM**

Location Address: **100 e lombard**

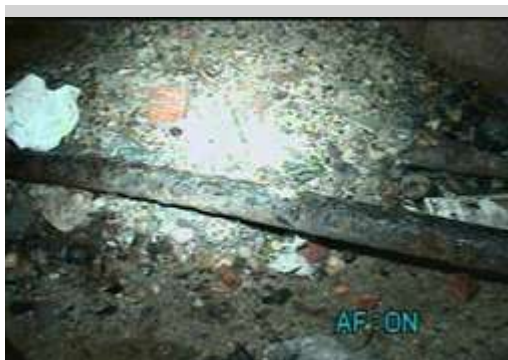
Defect 3

Condition: ☐ Sound ☐ Cracked ☐ Root Intrusion ☐ Deteriorated ☐ Leaks ☒ **Debris**

bench debris

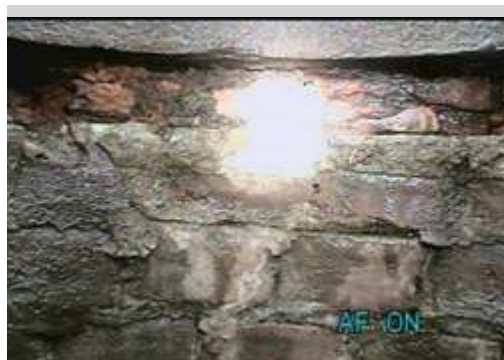
Defect 4

Condition: ☐ Sound ☒ **Cracked** ☐ Root Intrusion ☐ Loose Brick ☐ Deteriorated

crack in corbel

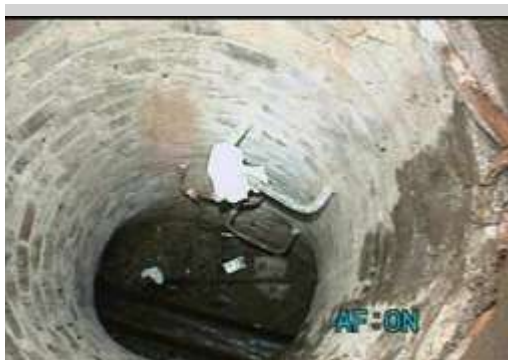
Defect 2

Steps Count: **4** Missing: **1** ☒ **Corroded**

steps

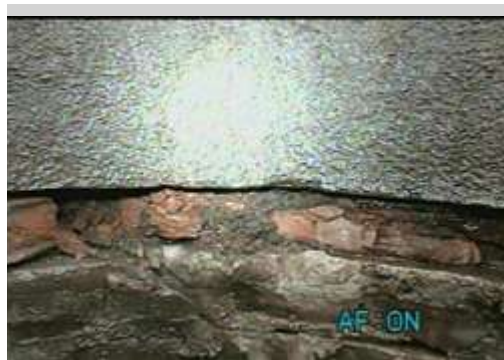
Defect 1

Condition: ☐ Sound ☐ Cracked ☐ Root Intrusion ☒ **Loose Brick** ☐ Deteriorated

chimney cond loose bricks

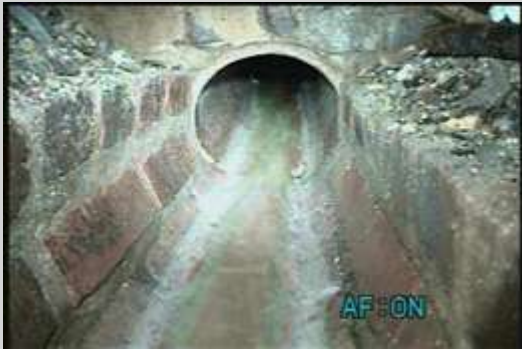
12 O'Clock Outflow

Pipe Material: **Clay** ☐ Pipe Lined

Invert Depth: **9.63** (ft.) Flow Characteristics: **Fast**

Deposits: ☒ None ☐ Mud ☐ Sludge ☐ Debris ☐ Grease

Infiltration: **None** Pipe Seal Cond: **Unknown**

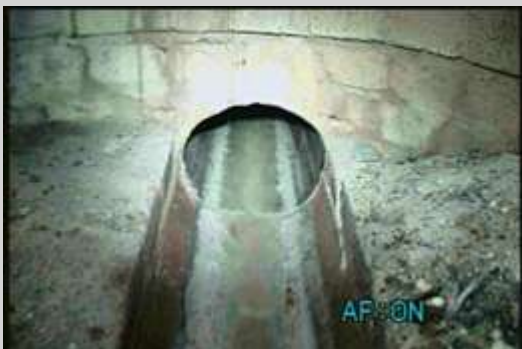
6 O'Clock Inflow

Pipe Material: **Clay** ☐ Pipe Lined

Invert Depth: **9.20** (ft.) Flow Characteristics: **Fast**

Deposits: ☒ None ☐ Mud ☐ Sludge ☐ Debris ☐ Grease

Infiltration: **None** Pipe Seal Cond: **Unknown**
